FAILURE ANALYSIS OF PITMAN ARM, INFLUENCE OF MICROSTRUCTURE ON FAILURE

Podany P. / Martinek P. / Miskova J.

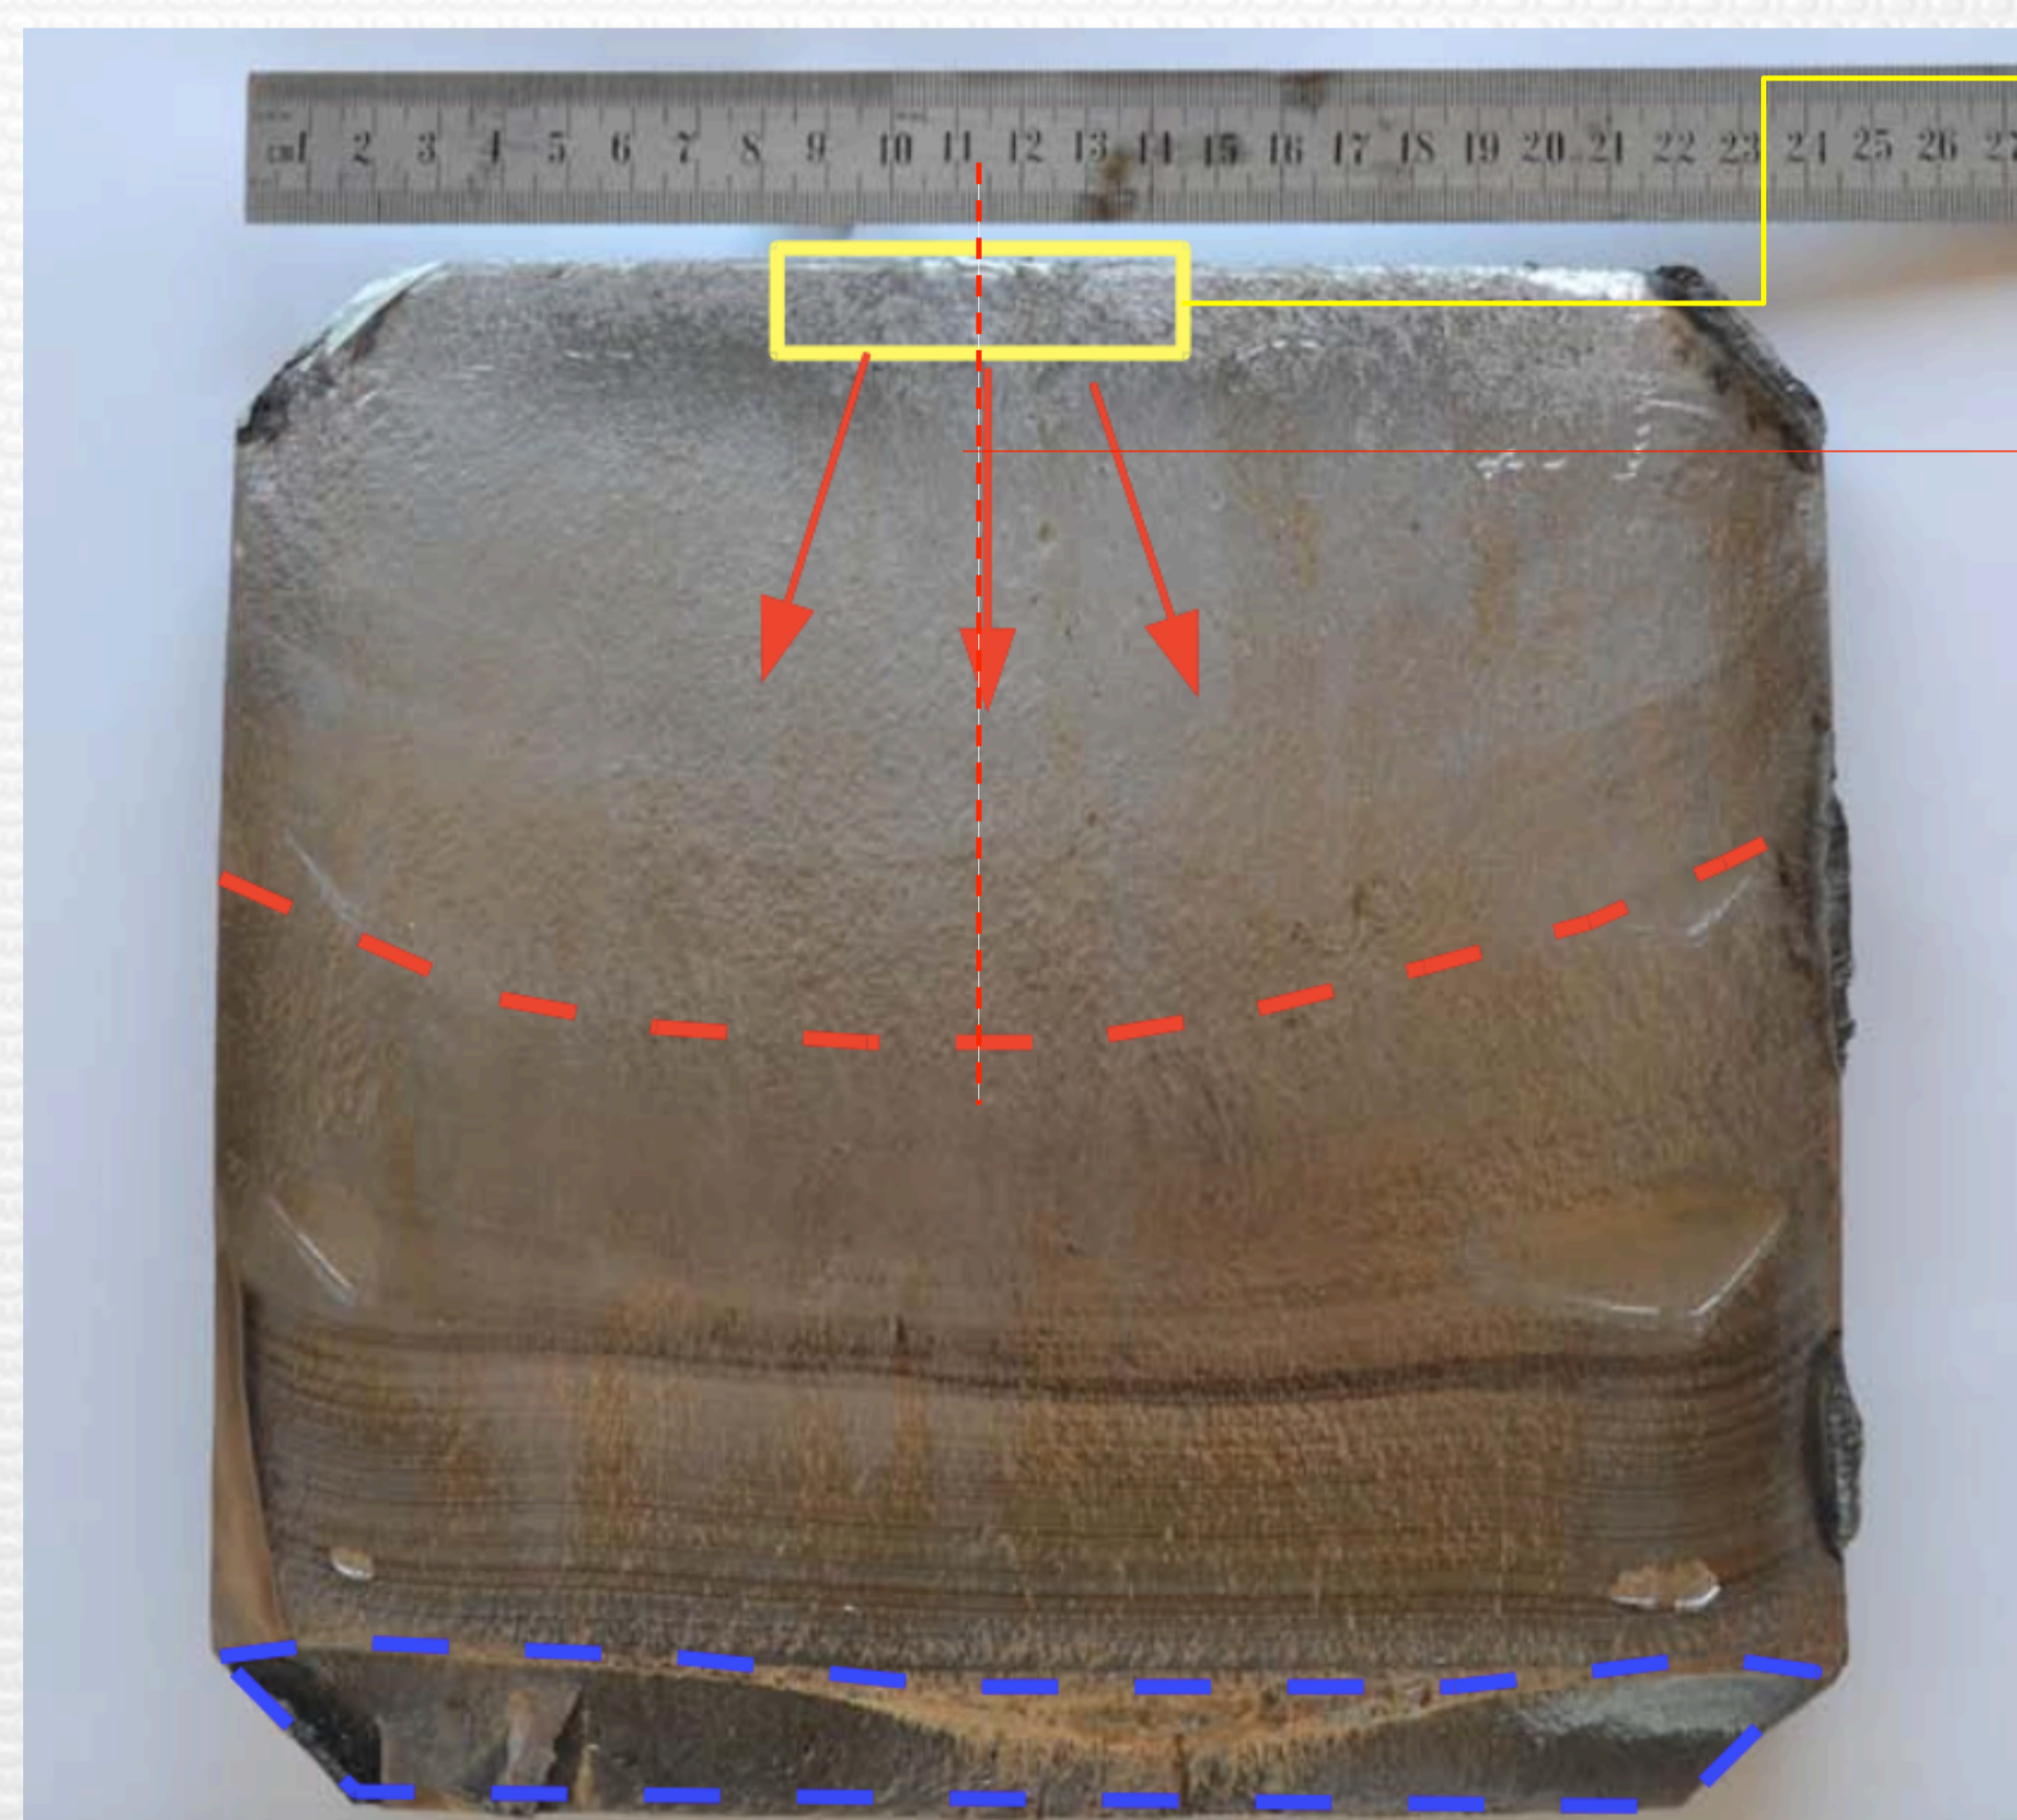
Fracture area of broken pitman arm

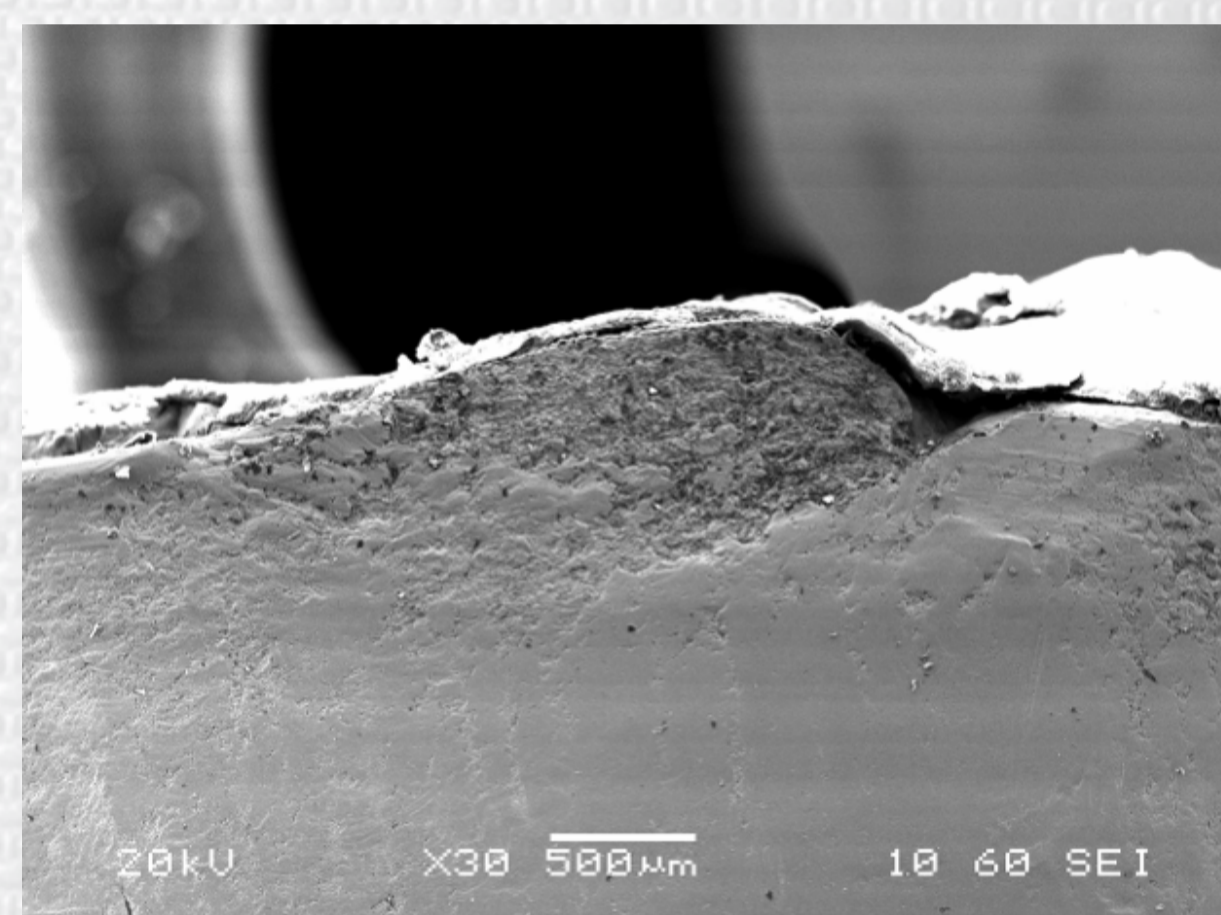
Locality of failure origin was observed by means of scanning electron microscope. Locality shows some marks of different fracture surface. This fact indicates different material or microstructure in the failure origin. There was also observed small cavity on the surface of arm. There was prepared sample for analysis of microstructure in the locality of failure origin. The cross section was made through the initiation locality. Microstructure was revealed by means of Nital etchant. There is a weld on the locality of failure origin (see figures on the right). There is clearly visible, that microstructure of arm is changed due to the welding process. Microstructure in the core of arm consists of ferrite and pearlite. This microstructure changed due to the weld into martensite near the weld. Microstructure in the weld metal is composed from bainite and widmanstaden ferrite.

Locality of failure origin (SEM)

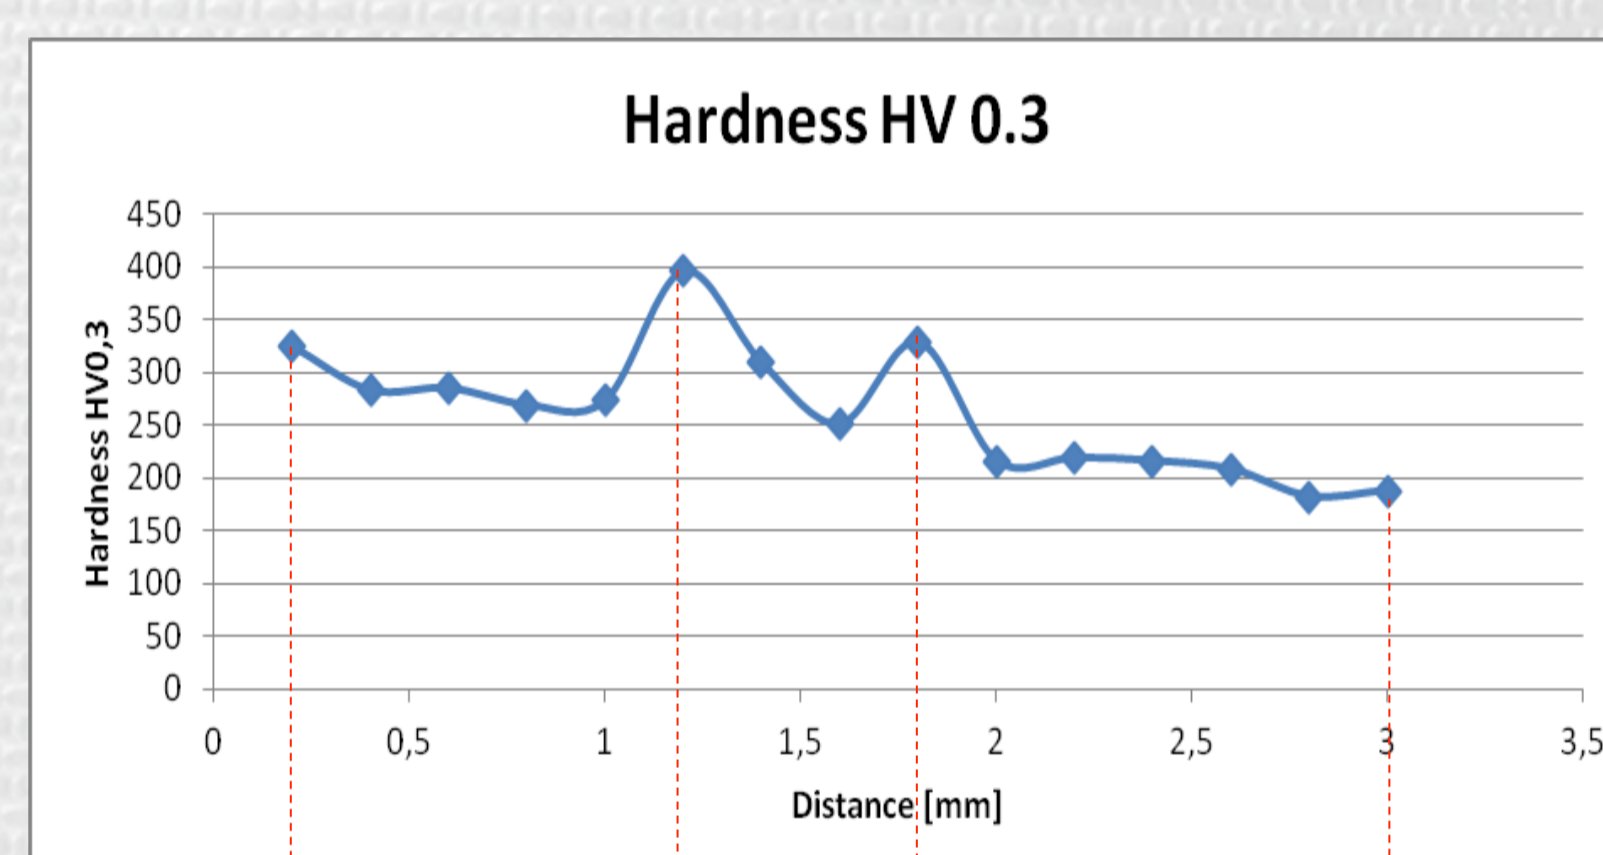
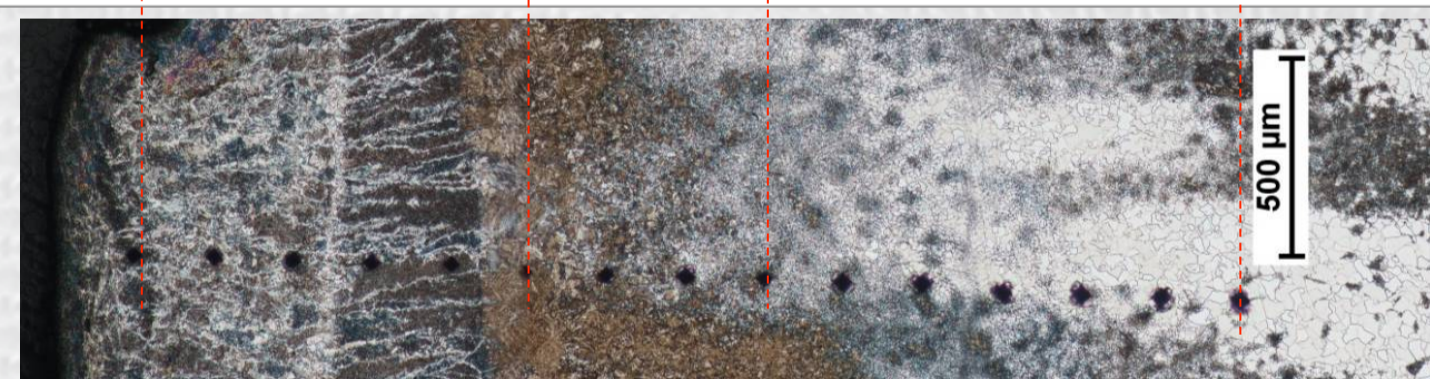
It is obvious that the weld in the microstructure considerably affect the hardness and inner stress in this locality of pitman arm. Microstructure shows, that the weld was not heat treated, there was no evidence of tempering in the martensitic microstructure below the weld. Therefore the hardness profile was measured on this sample by means of Struers Durascan 50 hardness tester. Load 0,3 kg was chosen for evaluation of Vickers hardness. Hardness was measured from the weld on the surface to the core of pitman arm. Hardness in the heat affected zone reaches 400 HV 0.3 (see figure above this text). This value is two times the hardness of pitman arm in not affected microstructure. This heat affected zone is the source of high inner stresses and in this case, it likely served as an origin of failure.

Hardness of the pitman arm affected by weld

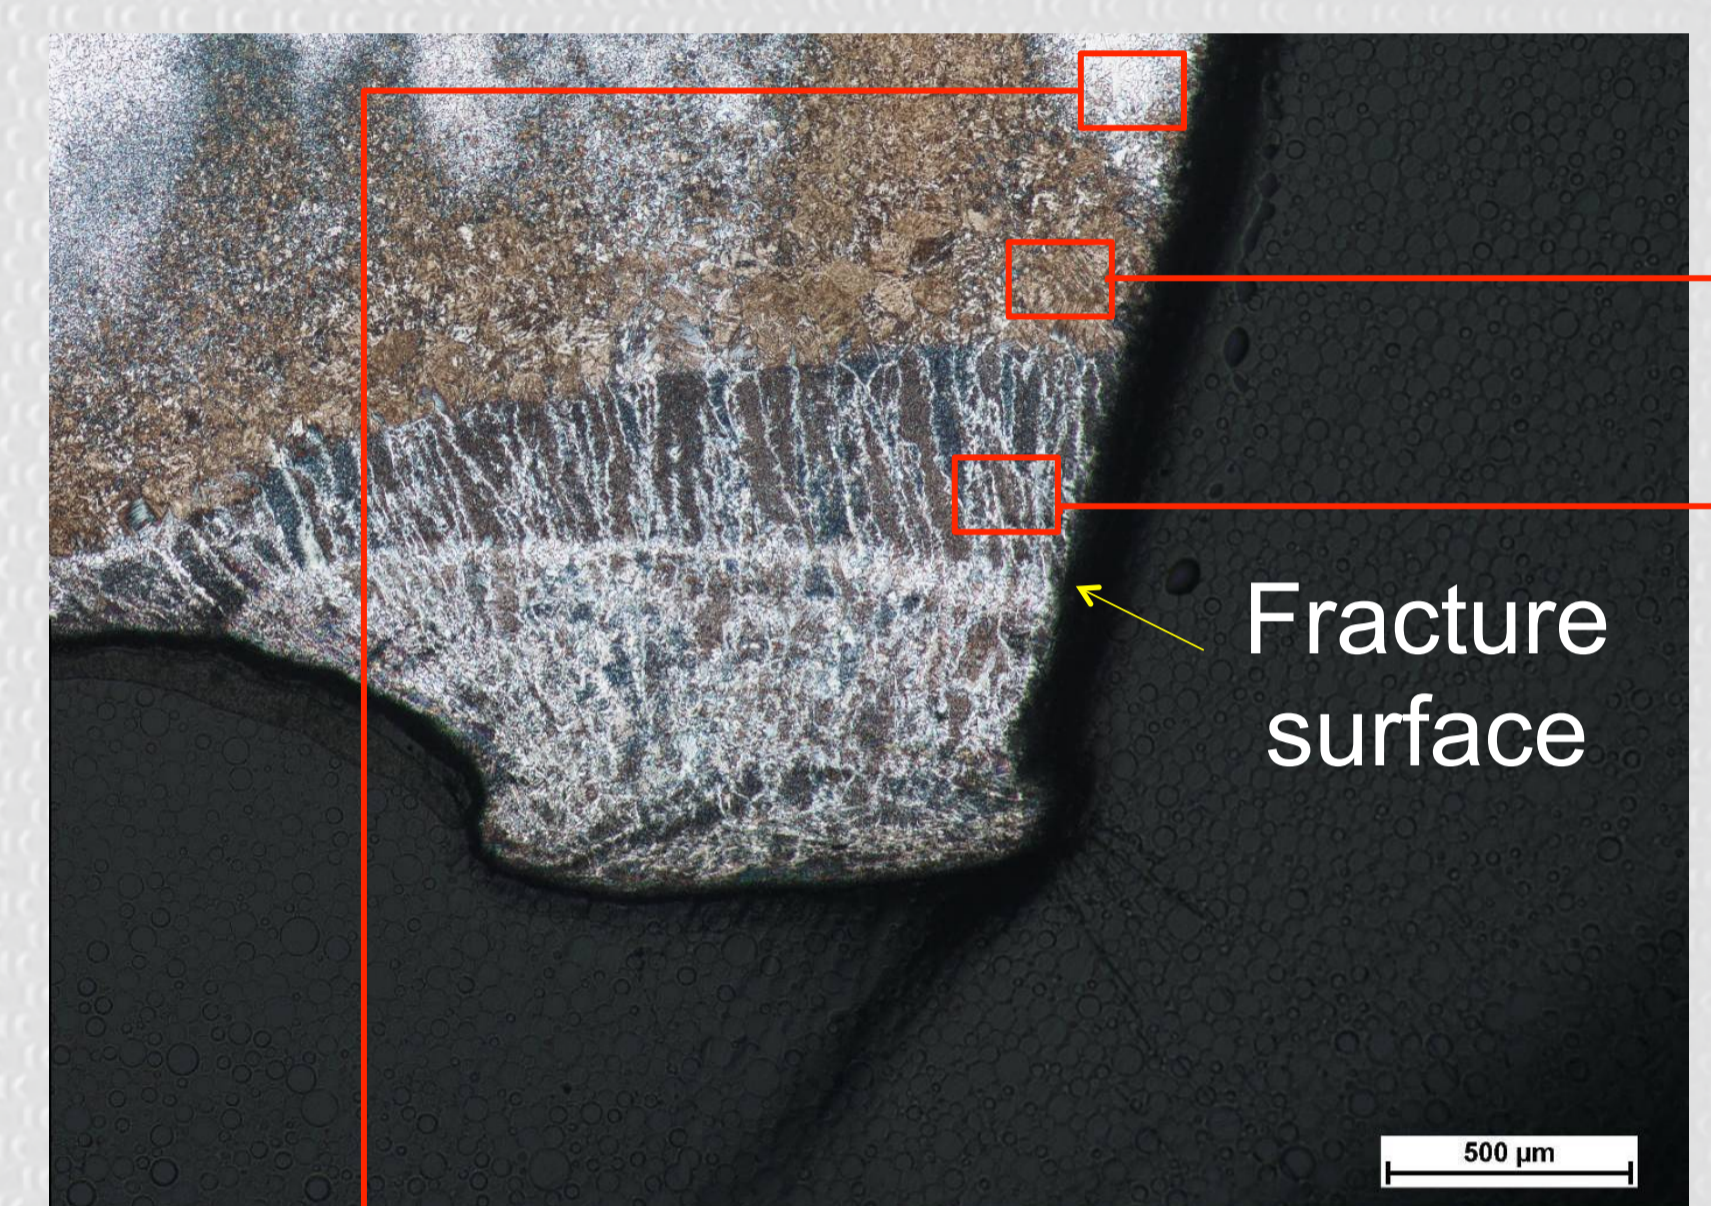
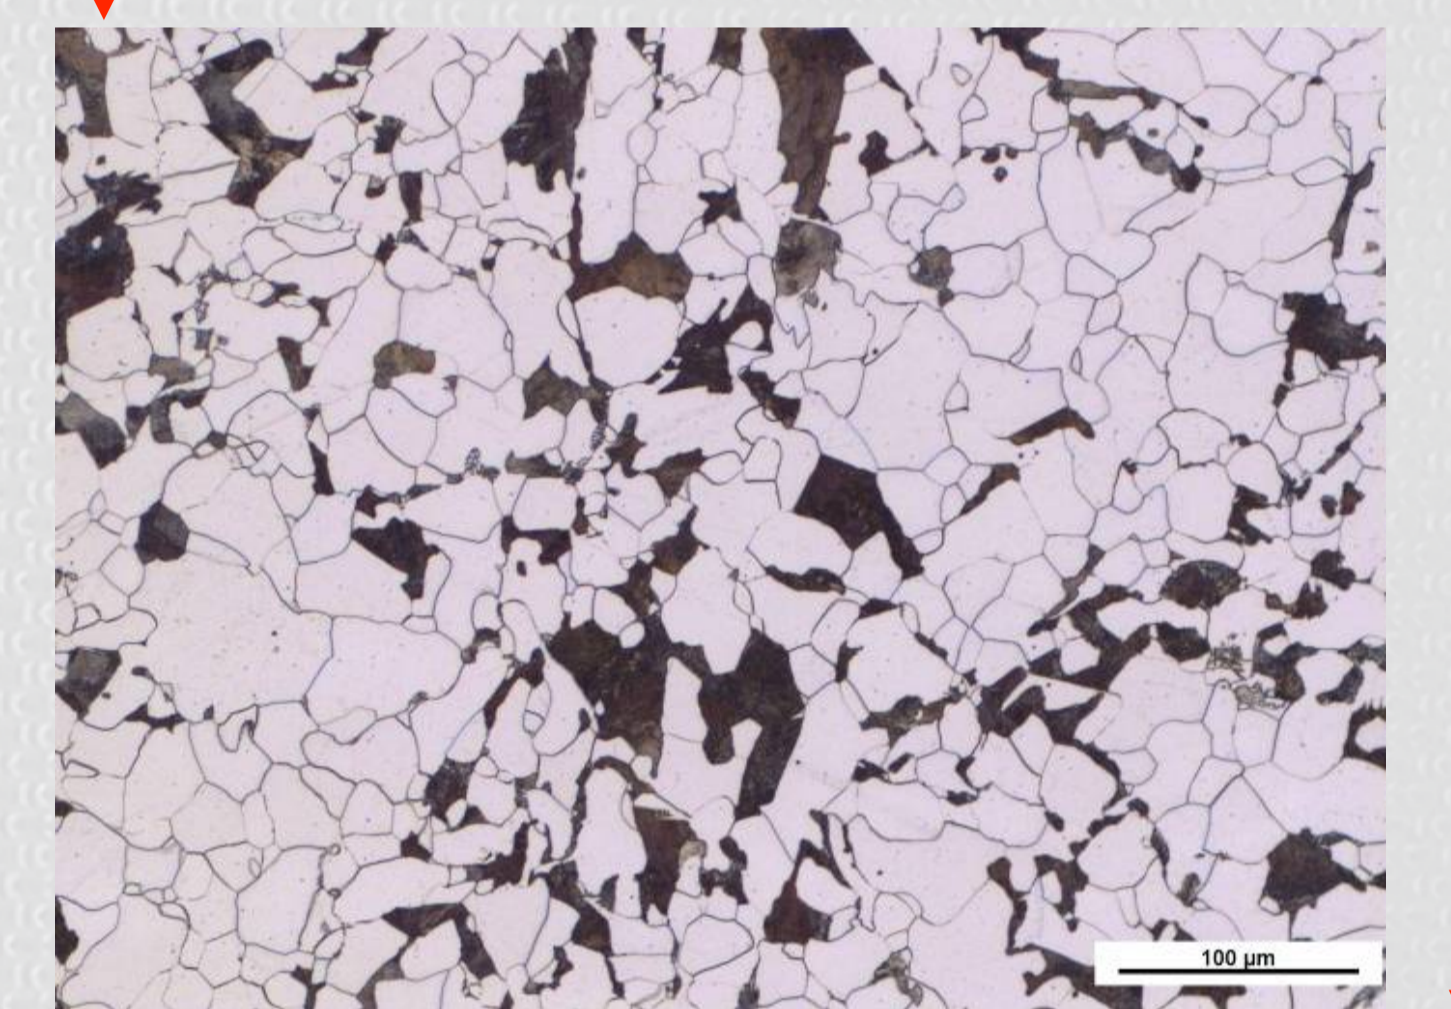
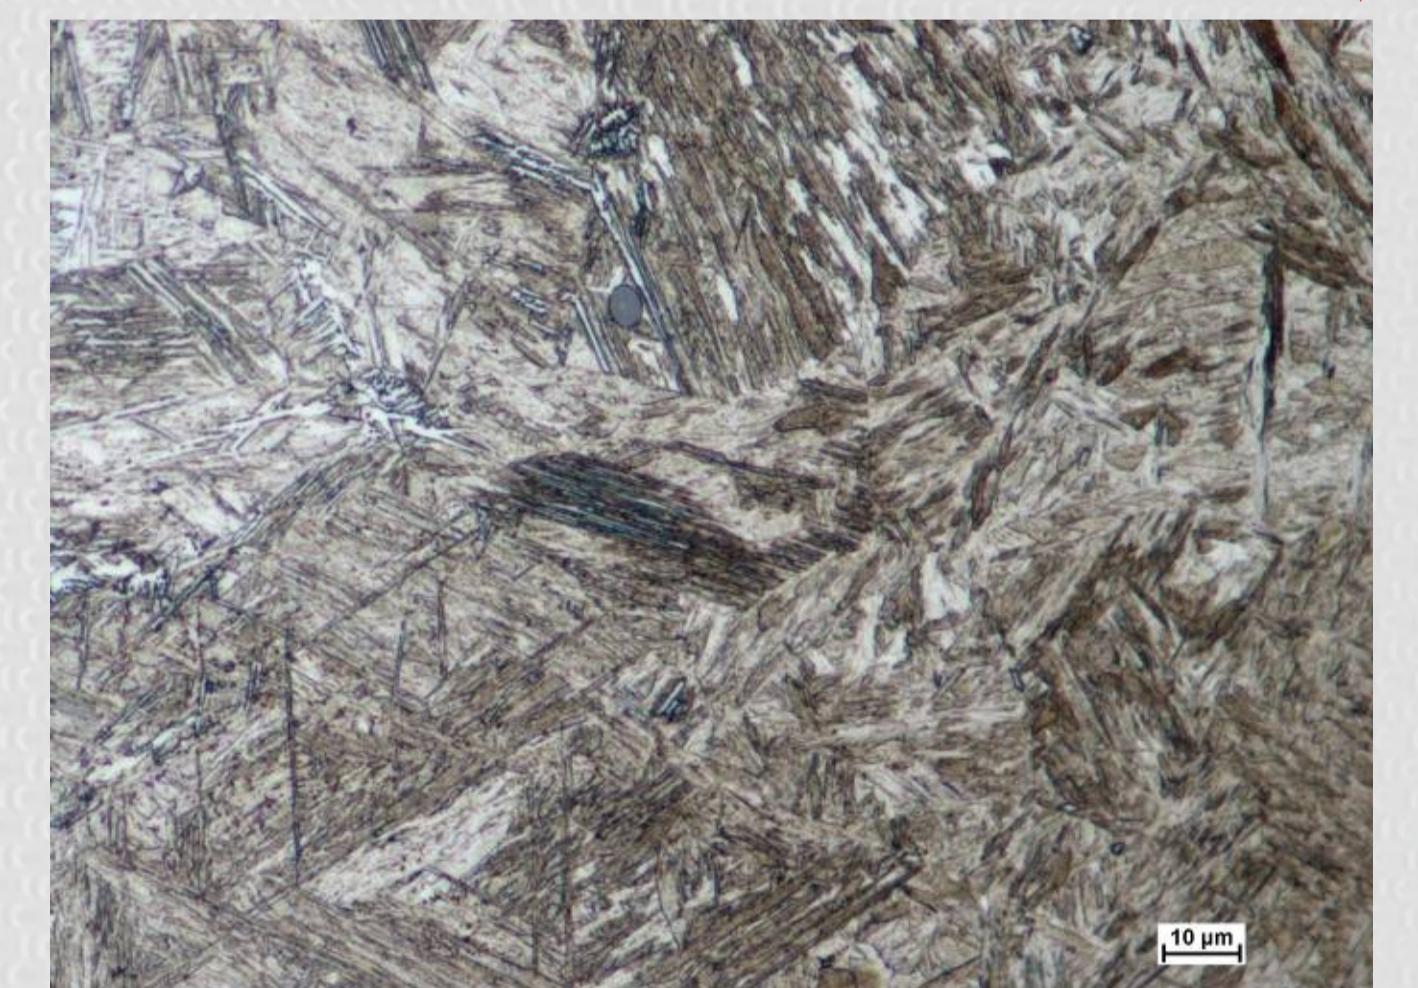
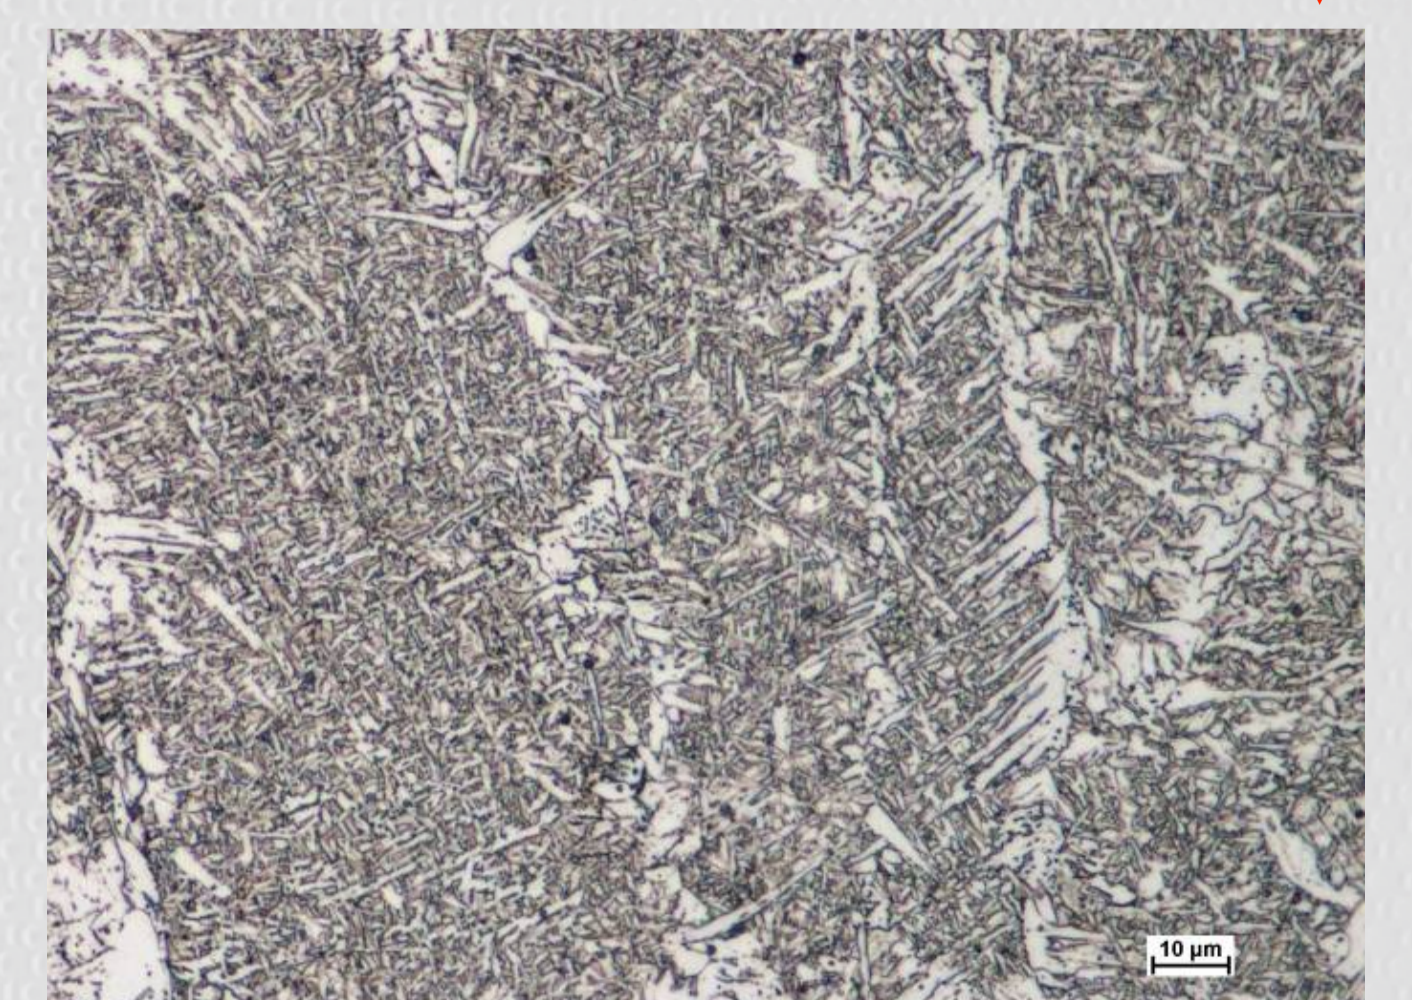
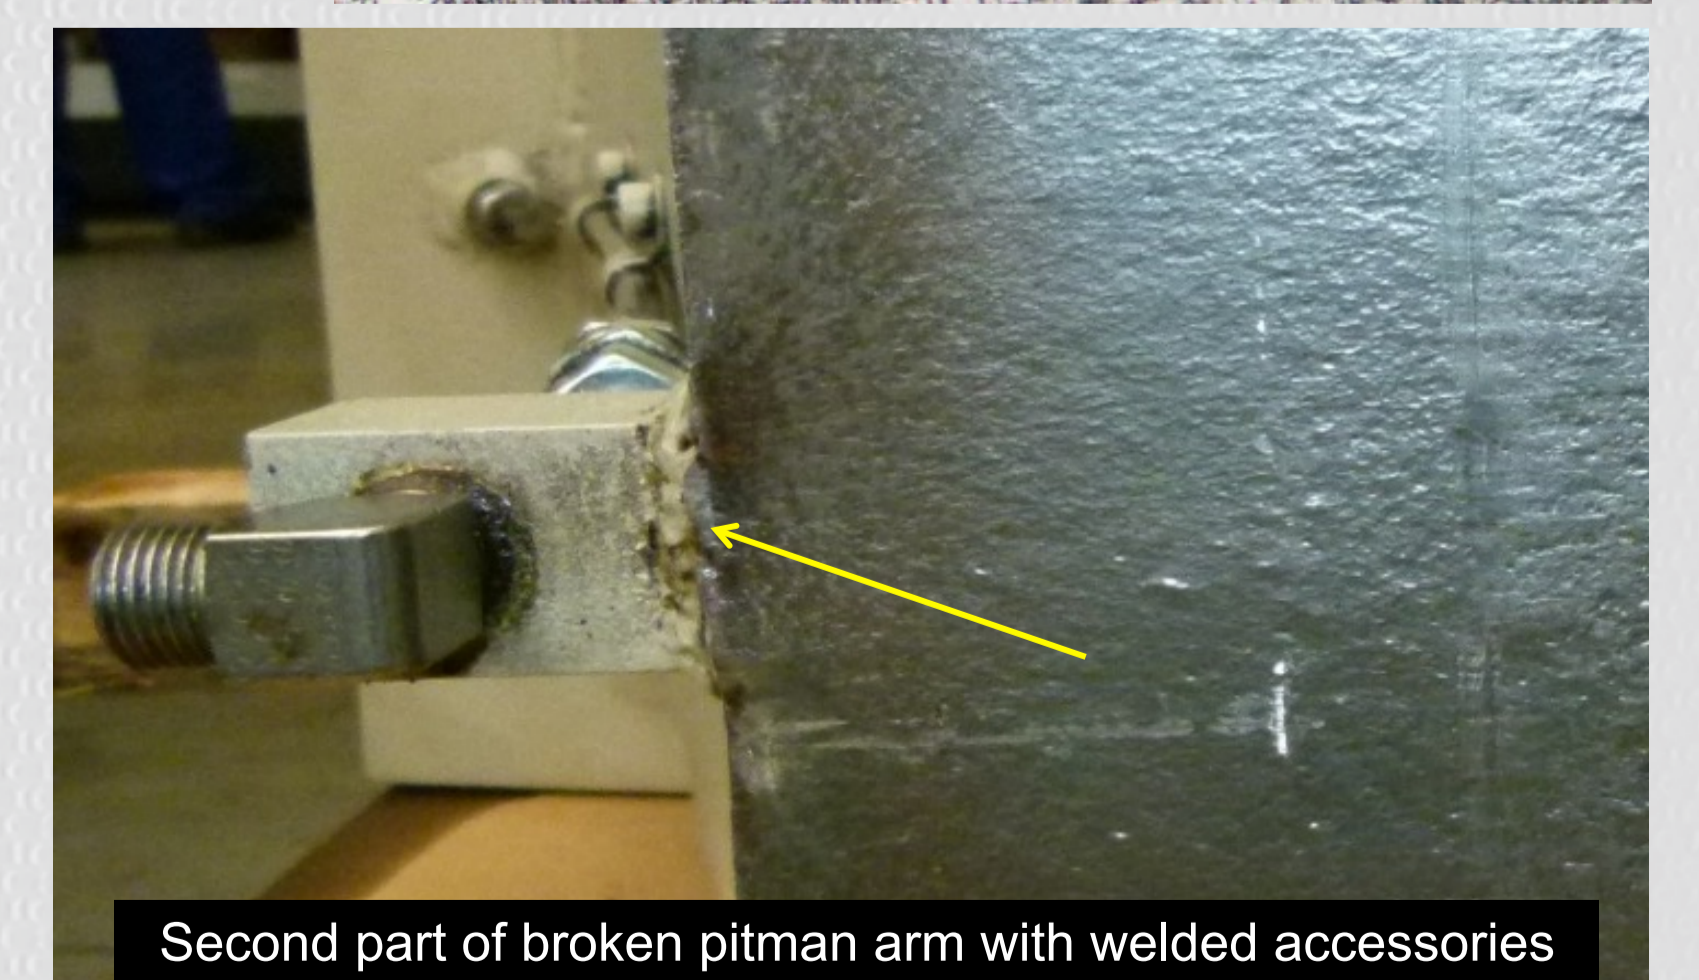
Microstructure in the failure origin (cross section)
